HOUSATONIC RIVER BASIN
WEST STOCKBRIDGE, MASSACHUSETTS

SHAKER MILL POND DAM
MA 00732

PHASE I INSPECTION REPORT
NATIONAL DAM INSPECTION PROGRAM

JULY 1979

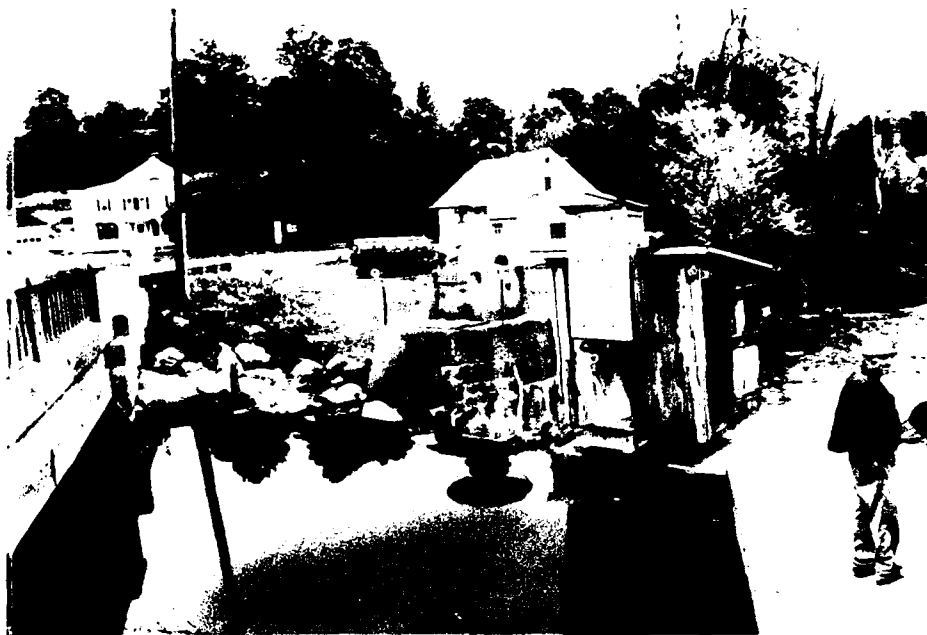
On the left (east) side of the spillway at the toe of the dam is an abandoned concrete structure which houses a turbine and generator, Photos No. 1, 6, 9 and 11. The walls of the structure are stained and show several cracks with efflorescence. The flow to the generator structure was controlled by a wooden gate operated through a wooden stem rack and pinion gear device, Photos No. 2 and 6. The gate is not operative. A hole was broken out on the downstream wall of the generator structure to allow the water seeping through the gate to return to the downstream channel, Photo No. 9.

6. Upstream side of dam
